**Situation Assessment Report:
Seekoei Estuary
March 2018**

Situation Assessment of the Seekoei Estuary

**Institute for Coastal and Marine Research
Nelson Mandela University
PO Box 77000
Summerstrand
Port Elizabeth**

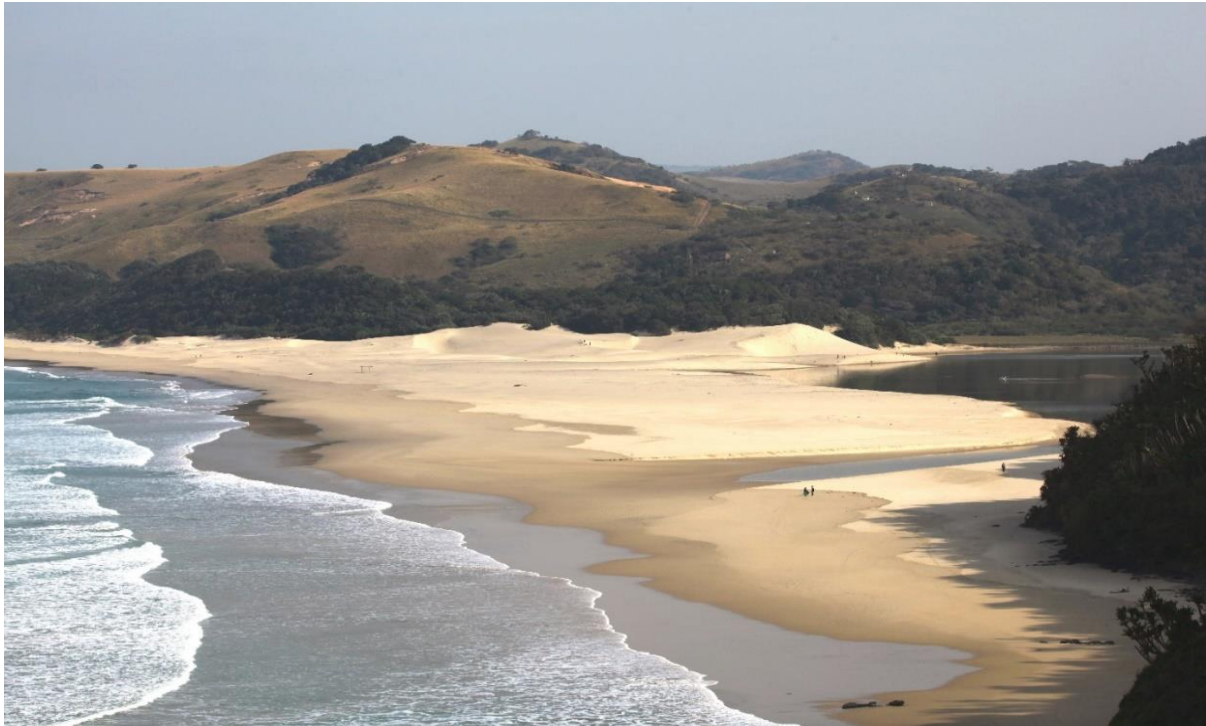
Plate 1 The Temporarily open/closed Mngazi Estuary (a short distance south of Port St Johns) a few days before final winter mouth closure. Typically, water levels in the estuary would slowly build up and with the onset of summer rains or a flood, breach the sandbar at the mouth and remove much of the accumulated marine sand. Natural breaching of an estuary mouth maximizes the probability of the mouth remaining open for longer compared to a premature artificial breaching event at a lower water level.

Associated with variability in estuarine salinity (that may range from near-zero to >35) is the state of the mouth, varying from wide open to fully closed with the development of a berm (Plate 1). Occasionally, the mouth may remain closed for extended periods (years) if river runoff remains low. Under closed mouth conditions, water movement driven by tidal action obviously ceases and wind

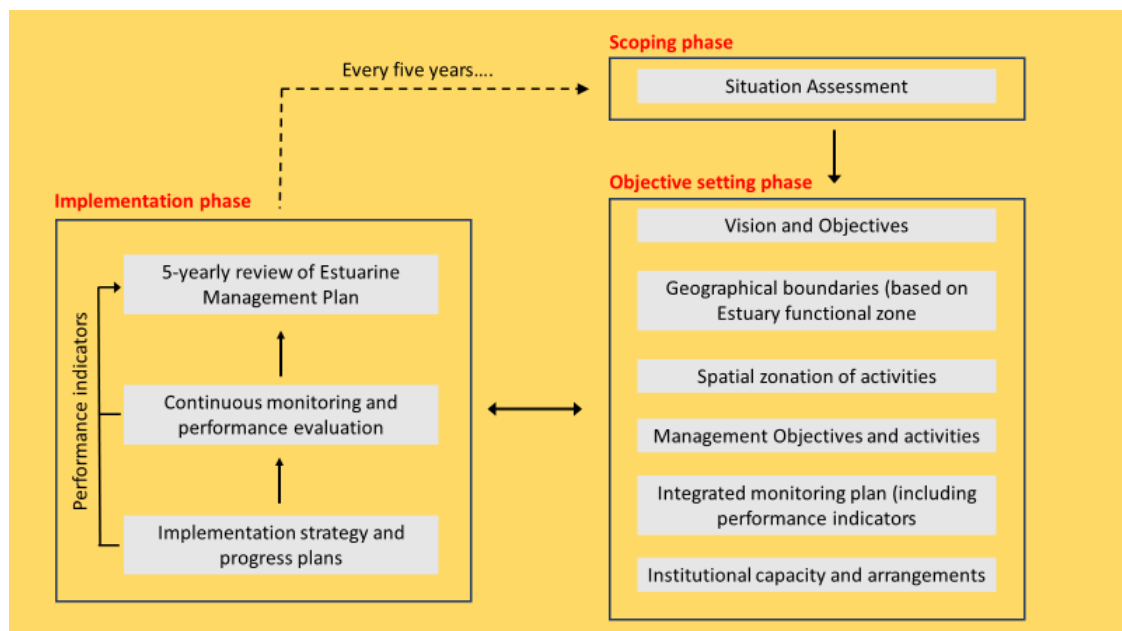
Figure 1 The framework for integrated estuarine management in South Africa.

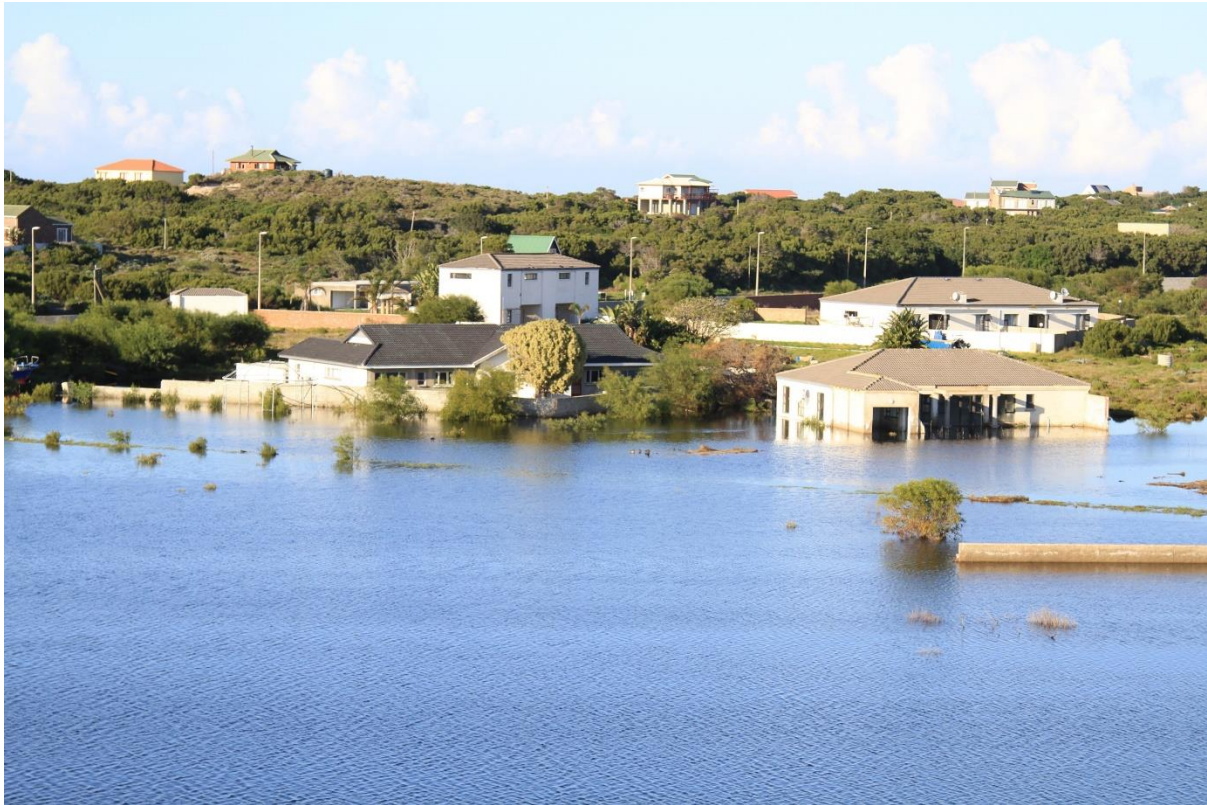
Plate 2 Housing development in low-lying areas are occasionally flooded after local rainfall flood the wetlands

From the earliest Topographical Survey images obtained (1942, Figure 3) the catchment of the Seekoei Estuary has mostly been under privately owned farmland (sheep, grazing and wheat) and remains so at present (Figure 4). The seasonal wetlands present within the 5 m estuarine functional zone (EFZ) (outlined by the red contour line and calculated to be 33.8 ha in extent, Figures 2 and 4) are partly transformed through housing development. On occasion, some homes are flooded by high water levels in the wetlands (Plate 2).

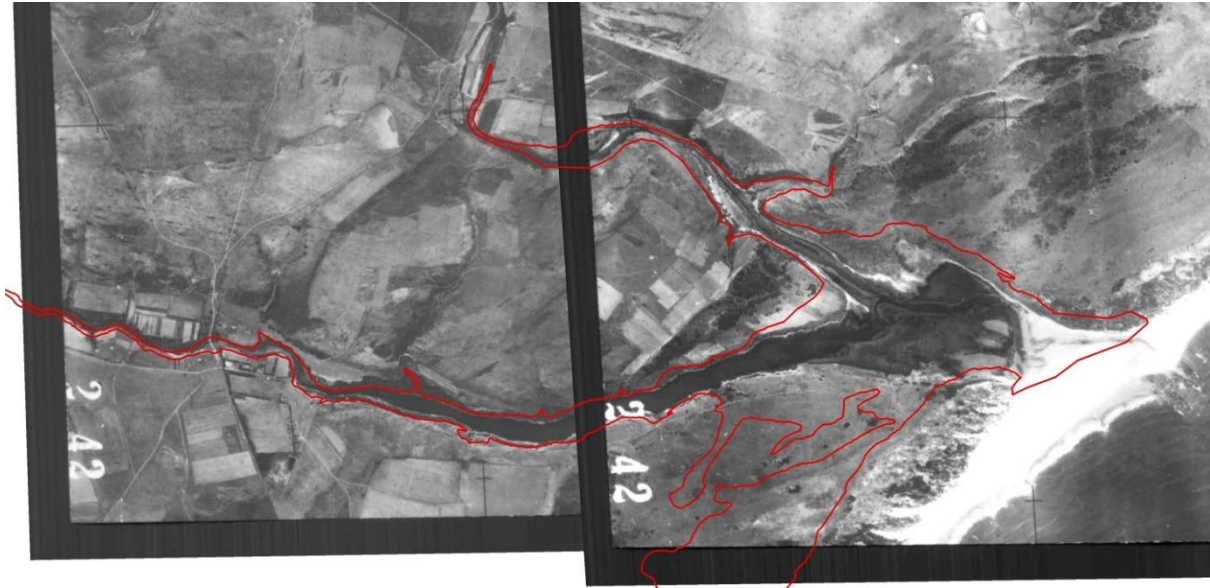
Figure 3 Aerial survey images of the Seekoei catchment in 1942, the 5 m contour line around the estuary is outlined in red.

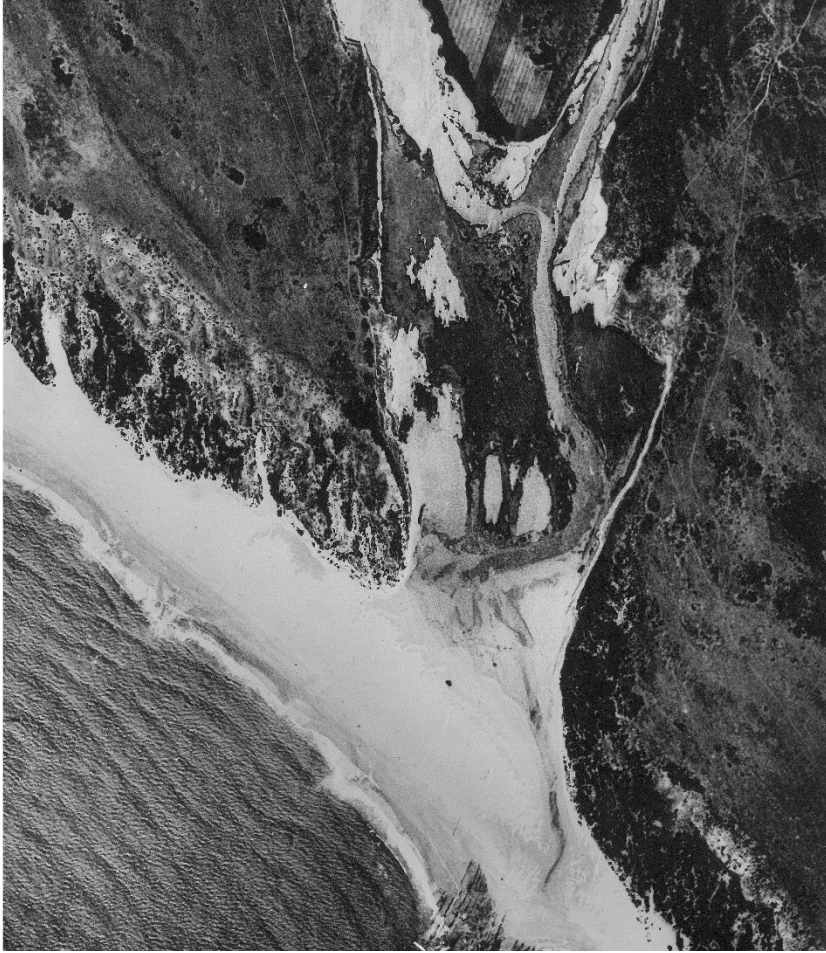
| DATE | CHANGE |
|---|--|
| 1942 image | <ul style="list-style-type: none"> • No evidence of residential development near the mouth area constraining the mouth position. • Mouth open with a narrow channel leading to sea. • Well scoured channels and wetted perimeter in lower reaches may indicate a recent breaching. • Dark areas in inlet channel may be bedrock showing through, but could also be shadows from a deep channel. • Water level very low with exposed sand banks up side of present causeway visible indicating that even with a breaching over rocky sill the estuary still drained significantly (i.e. rocky sill to not obstruct outflow as much previously assumed) • Farmland visible between Swart and Seekoei tributaries, as well as upper reaches of both tributaries • Algoa Dune Strandveld cordon along coast mostly vegetated (80%) • Crossings upstream of the Seekoei tributary (1.8 kms) |

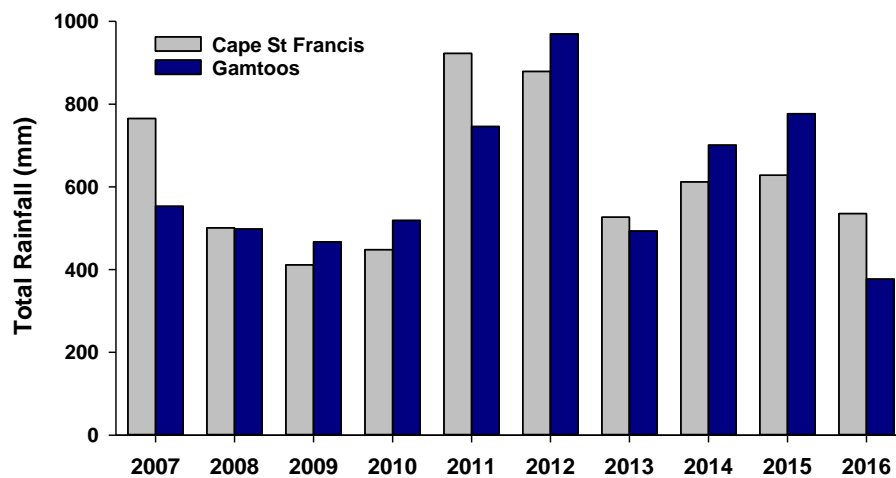
Figure 6 Rainfall (mm) recorded at the Gamtoos River Mouth Resort and Cape St. Francis weather station, 2007 – 2016. The data show high variability between years, following the pattern typical of dry climates in general. Although the total rainfall per year differs from that recorded at Seekoei, variability will be similar. Gamtoos data from Wooldridge, unpublished; Cape St. Francis data from SA Weather Service.

Because of the high variability between years (refer to Figure 6), damming/freshwater abstraction can have a critical influence on the structure, natural functioning and evolutionary pathway of the estuary, particularly during dry phases (Whitfield and Bruton 1989). Abstraction schemes impact an estuary in different ways, including:

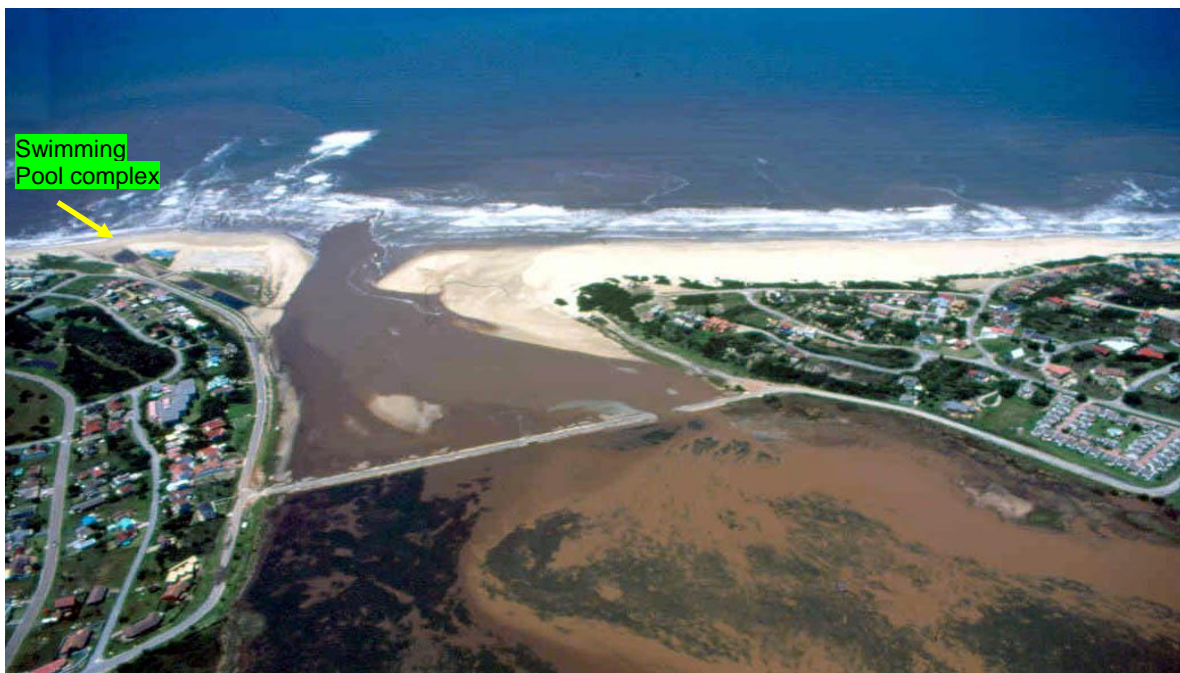
Plate 4 At the time of this photograph (mid 1980's), the original rubble causeway had been breached and floodwaters eroded a relatively deep and wide channel. The photograph also shows a plume of discoloured estuarine water radiating from the mouth – refer to Figure 7 (Photograph from T Wooldridge).

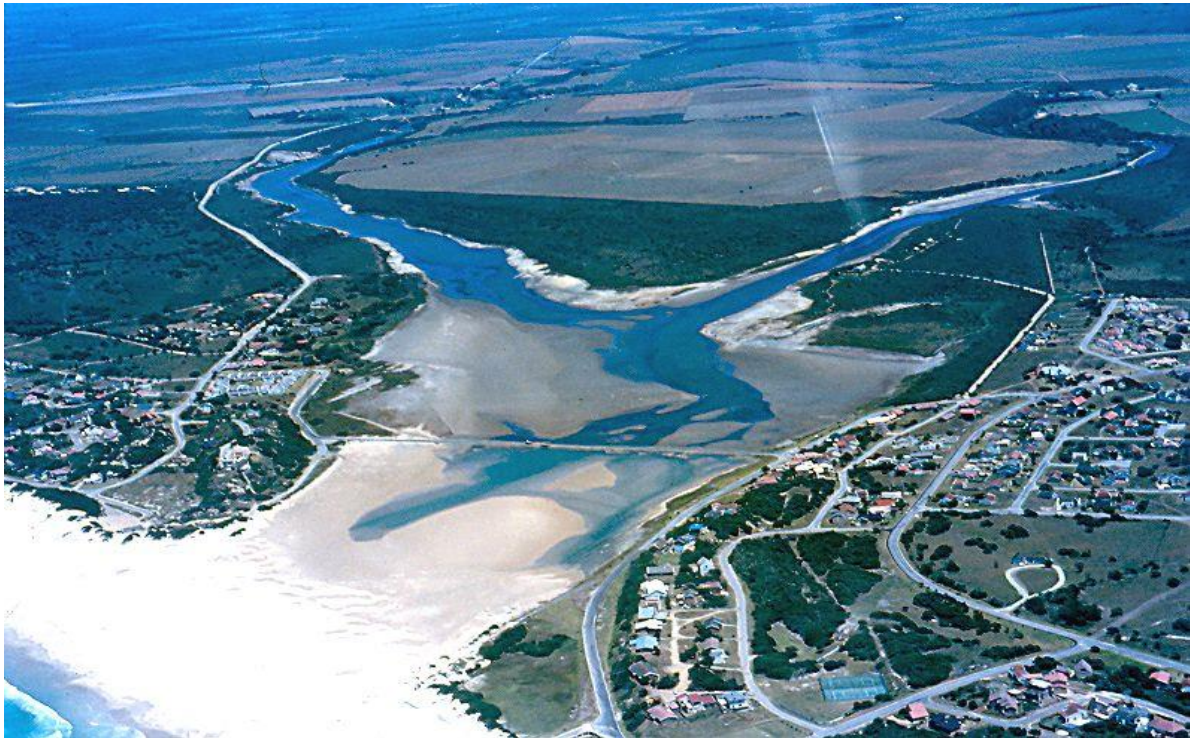
Plate 5 View of the Seekoei from mouth to catchment area, demonstrating the separate channel basins at the mouth area. Photograph from T Wooldridge.

Fluctuations in water level and salinity impacted negatively on waterfowl in the estuary whose numbers began to decline significantly. This led to the establishment of the Seekoei River Nature Reserve in 1969 (under Provincial Management), encompassing the northern part of the estuary and triangular piece of land between the Seekoei and Swart Rivers (see Plate 5). The reserve was primarily

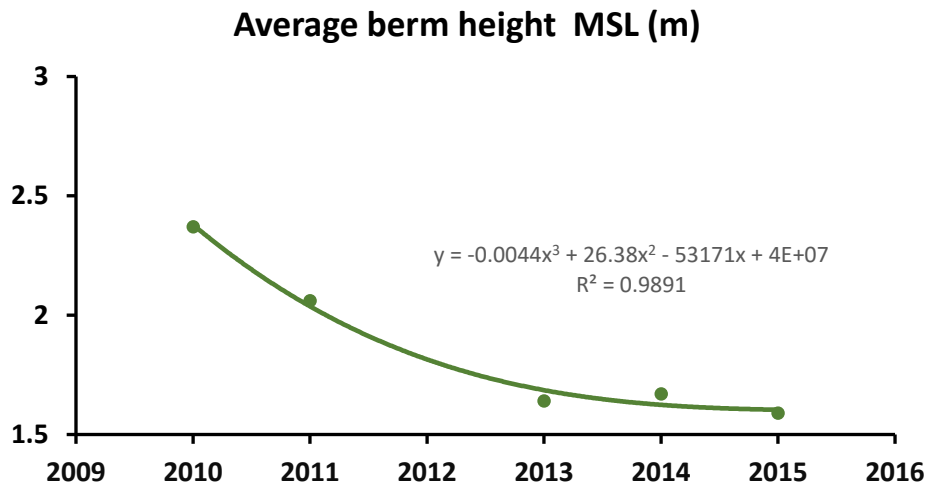
Figure 10 Average berm height (m) above MSL across the mouth of the Seekoei Estuary between 2010 and 2015 inclusive. Fixed points were measured monthly between two base stations as set out in Table 6.

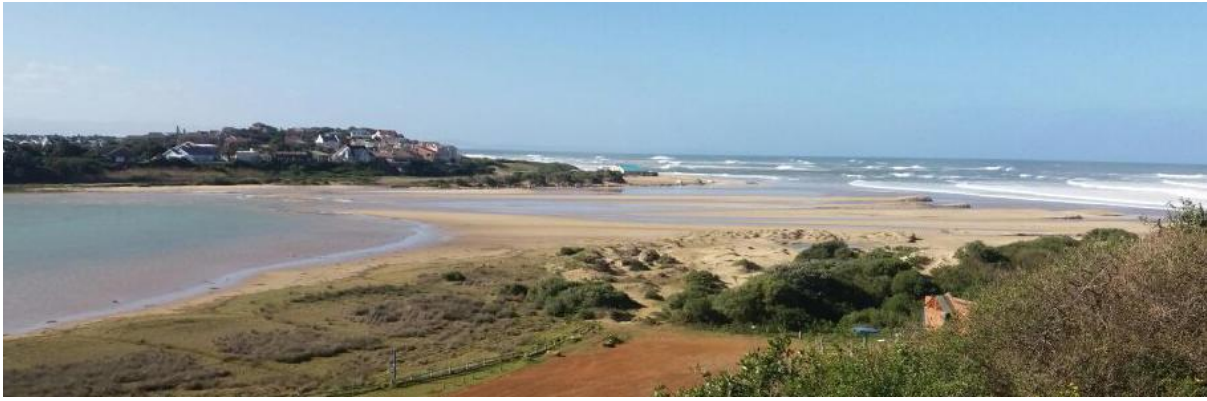
Plate 6 The flattened berm is clear in the photograph above. The photo was taken during the spring tide cycle and three hours before the peak of high tide on 24th June 2017.

The low berm height was still evident in June to August 2017 (Plates 6 and 7). Information suggests that overtopping of the berm by wave action occurs under storm conditions, particularly if they coincide with spring tides. Numerous records are available indicating flattening of the berm by wave action is intermittent, linked to storm events. The photograph below (Plate 6) was taken on the 24rd June at approximately 1 pm and two days after New Moon. At the time, no riverine input to the estuary was evident. Water volume in the estuary was probably maintained at the observed high level by berm over-wash of seawater.

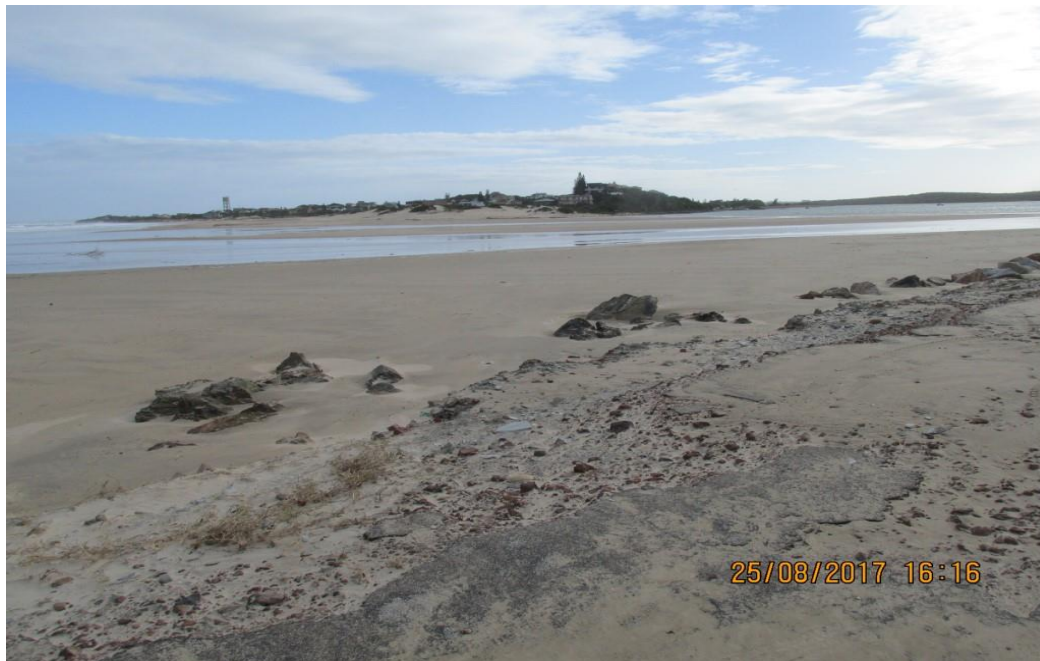
Plate 7 Large volumes of sand were transported on the high tide into the estuary on the 24 and 25th August 2017. Photo by Hennie Swanevelder – Department of Economic Development and Environmental Affairs.

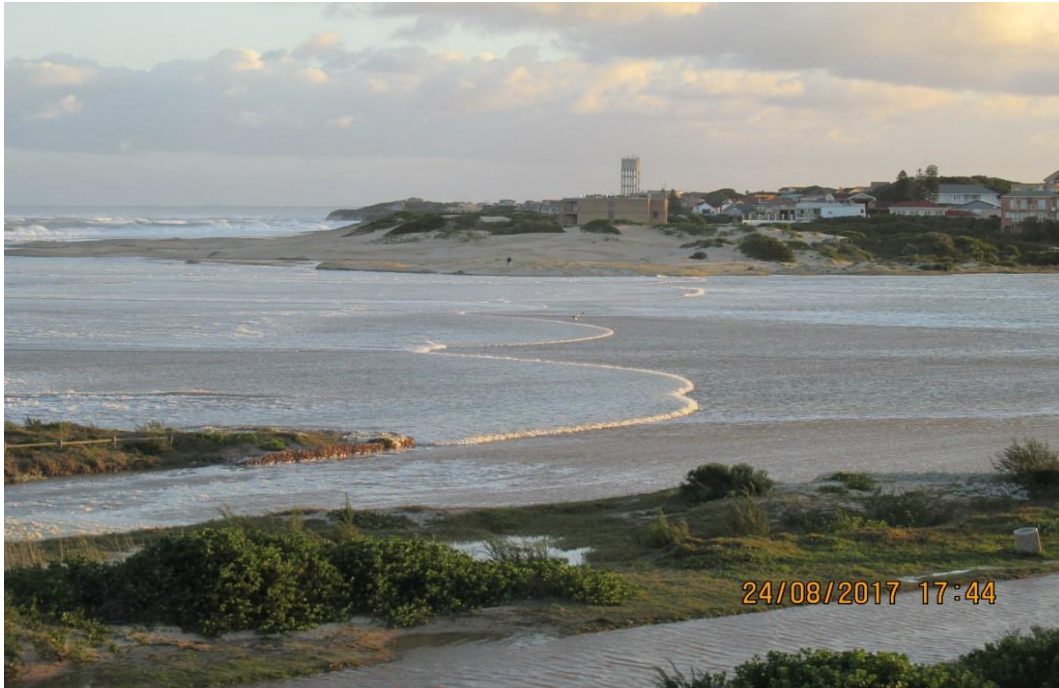
Plate 8 Berm overwash occurred around high tide on 24 August 2017. The estuary was rapidly filled, with the tide also overwashing the causeway. Depth of the water across the berm peaked at about 40 – 50 cms. During such events, large quantities of marine sand are deposited in the estuary. Photograph from Hennie Swanevelder – Department of Economic Development and Environmental Affairs.

A further overtopping of the berm occurred on the 24th August 2017. The event happened shortly after spring tides. A major storm swept across the south coast at the time (Plates 6 – 10). Plate 11 further illustrates the danger of crossing the causeway when covered, even when water depth is just a few centimetres.

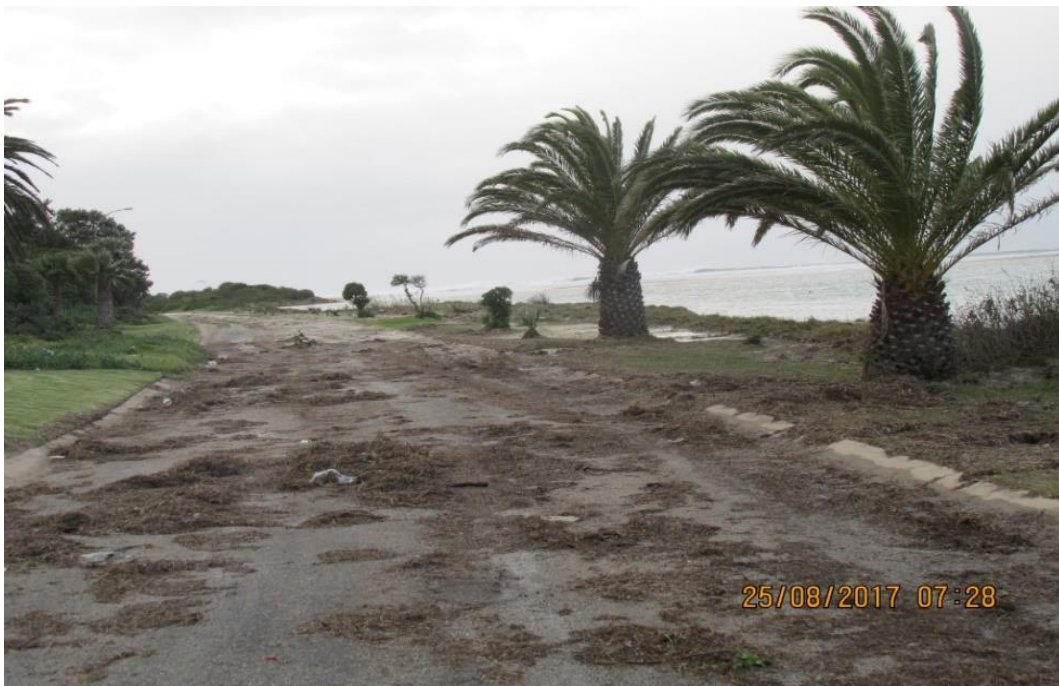
Plate 9 Berm overwash shown in Plate 8 deposited large quantities of flotsam on the Aston Bay road running parallel to the estuary. Photograph from Hennie Swanevelder – Department of Economic Development and Environmental Affairs.

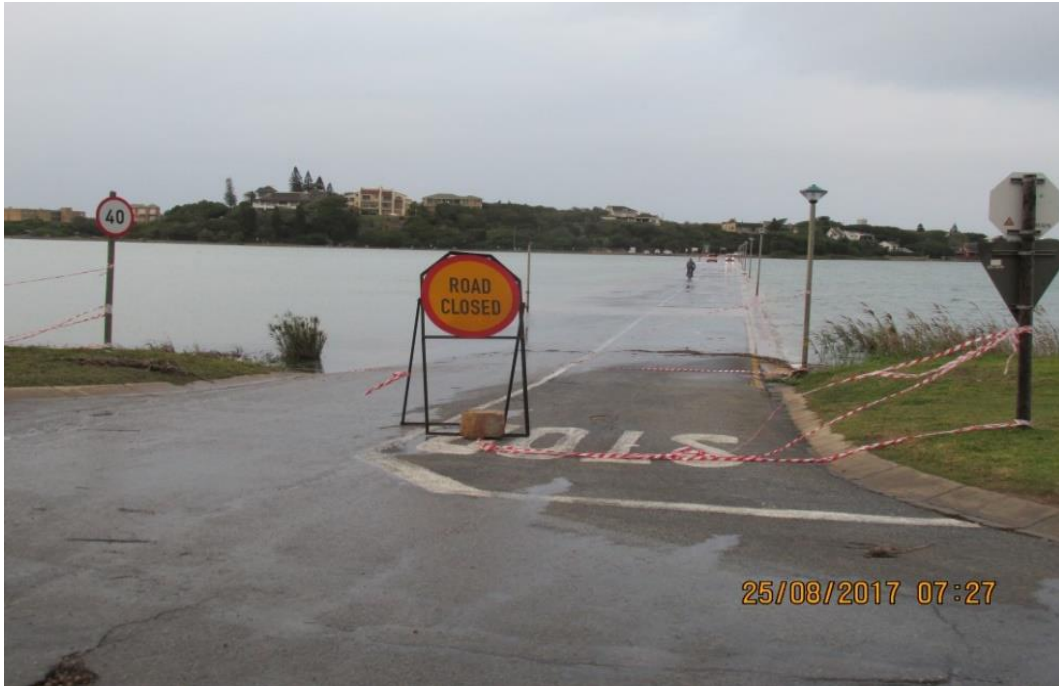
Plate 10 Berm overwash shown in Plate 8 resulted in the causeway overtopping with seawater. Zero freshwater inflow to the estuary occurred around this time, so that salinity levels in the estuary would remain at 35 or higher. High rates of evaporation would rapidly result in hypersaline conditions developing in the estuary as the estuary closed again within 48 hrs. Photograph from Hennie Swanevelder – Department of Economic Development and Environmental Affairs.

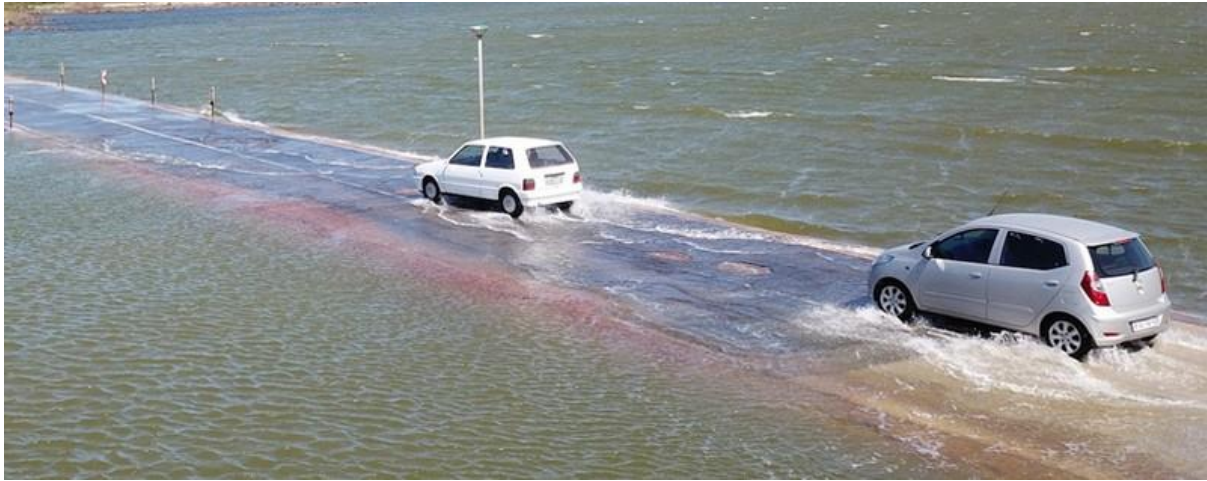
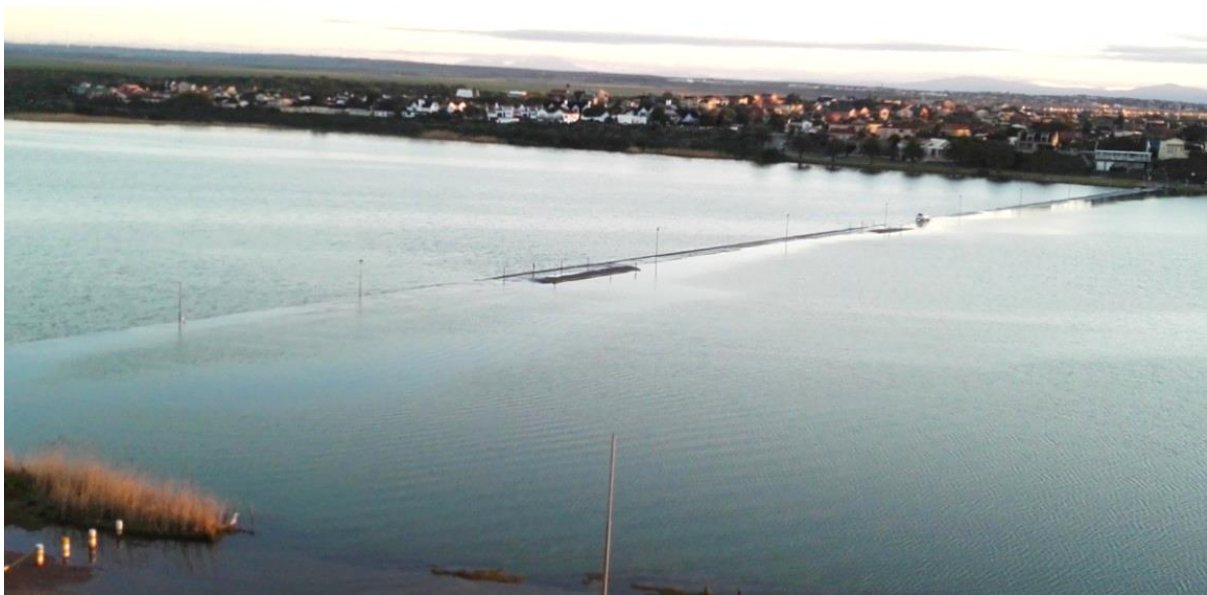
Plate 11 Overtopping of the berm causes significant damage to vehicles (electrical issues included) and puts life at risk (vehicles sliding off the causeway, pedestrians crossing on foot), particularly under windy conditions. Both photos demonstrate the undulatory nature of the roadway.

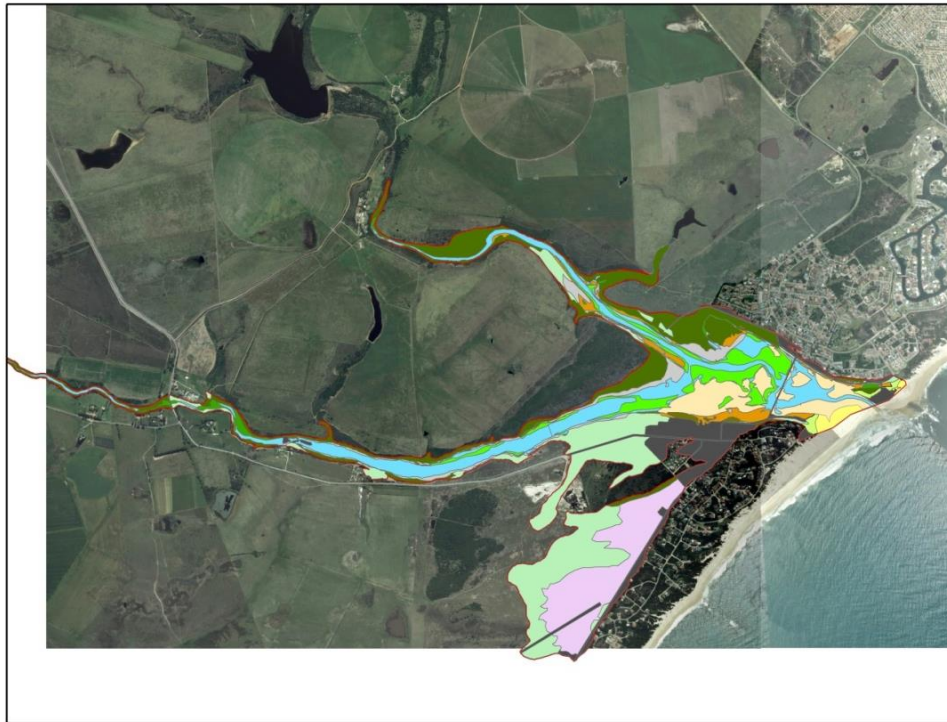
| Figure 13 | Present habitat distribution (2017) in the Seekoei Estuary. | 45 |

Where possible vegetation was mapped for these images but poor black and white quality made this difficult and mapping confidence for these years is low. Where mapping could not be done a percentage of the total EFZ (estuarine functional zone) was estimated. Table 11 and Figure 13 show the present vegetation area for the Seekoei Estuary and where possible, historical area within the 5 m EFZ. Sand banks and submerged macrophytes are included in the open water area. Floodplain includes disturbed areas like grassed and disturbed areas and farming. Roads, causeways, air strip and residential areas were mapped under “development”.

In broad summary, Table 11 suggests that vegetation cover for most of the plant types in the Estuarine Functional Zone (EFZ and below the 5m contour line) has not changed significantly. Variations that exist are probably linked to the degree of submergence between dates. Salt marsh area cover reflects high variation between dates and is probably linked to changing abiotic conditions particularly water level.

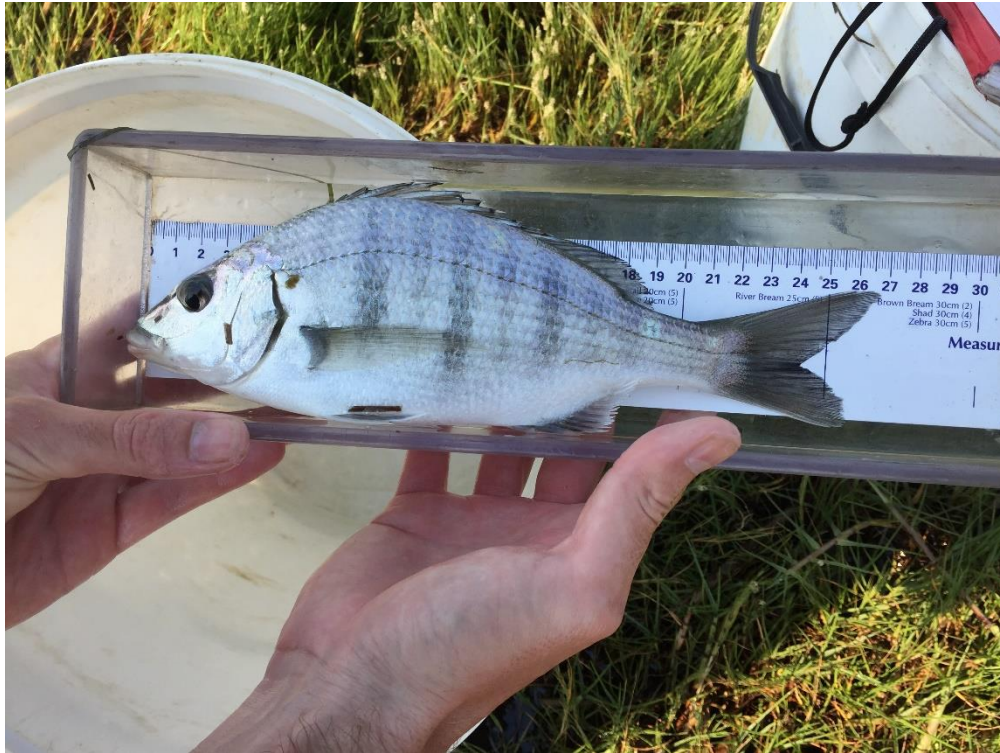
Plate 12 White Steenbras collected from Seekoei estuary. Photograph from Nadine Strydom.

Despite the loss of hundreds of young fishes in the Seekoei during high salt levels where salinities rose above 55 in summer, White Steenbras were able to move to areas in the upper estuary to find lower salt content. This highlights the importance of migration routes staying open to fishes to move upstream during unfavourable conditions – this however is impeded by weirs, causeways and dams. Fishes then accumulate below such obstacles *en masse* and increased competition results. The proper management of the mouth for the estuary to prevent hypersalinity and the removal of unnecessary dams to improve baseflow will provide a reliable refuge and nursery area for this species.

The Seekoei Estuary is an important nursery area for the threatened White steenbras, *Lithognathus lithognathus*, where numbers are unusually high prior to recent fish kills from salt content rising more than 20 units above sea salt levels (Plate 12).
